## *THE CHRISTCHURCH ANTIQUARIANS*

### ***Newsletter, Spring 2019***

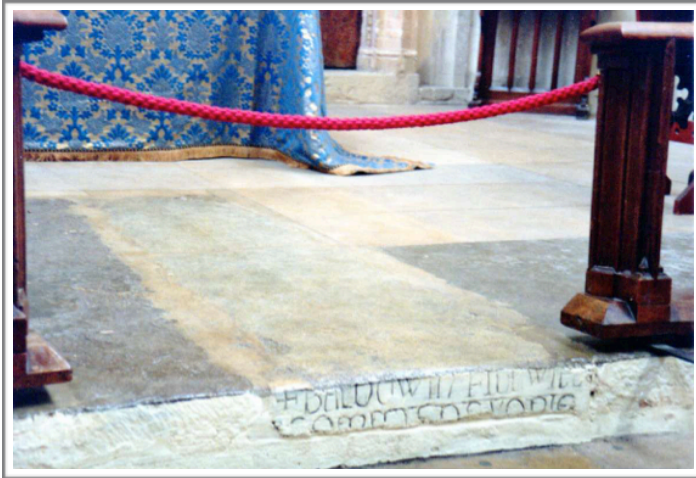
**Photo 1:** Baldwin III's tombstone in front of high altar in the Quire, with the carpet removed in 1994

The tombstone of *Baldwin III* is under the carpet in front of the high altar in the Quire. Visitors had the opportunity to view it in 1994 when the carpet was removed (Photo 1). It is set into the top step by the altar rail with its worn Latin inscription on the riser. Spread over two lines it reads:

In 1994 I noticed that the stone had a diagonal crack across it, which probably occurred when the tombstone was moved during the 15<sup>th</sup> century rebuilding of the Quire and the alterations to its crypt.

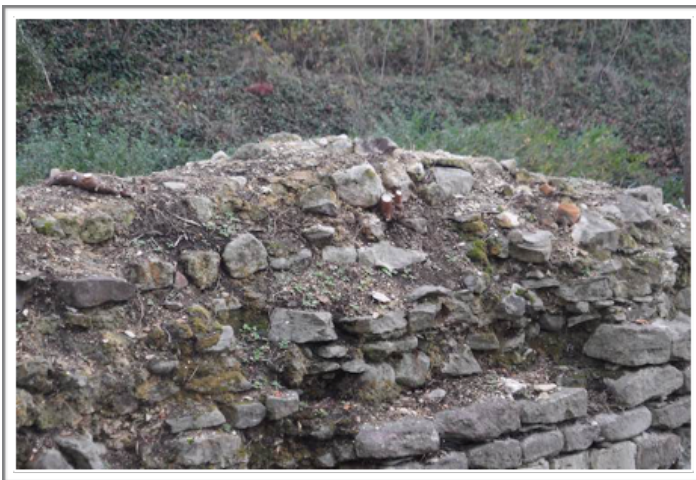
**Photo 3:** *The walls clearly still remain in a precarious state*

Priory. Some may have been startled by the openness of the aspect now revealed (Photo 2); certainly it presents a greatly different prospect to the shrubby banks we encountered in 2010. My feeling is that the clearance gives proper prominence to the ancient walls which remain, and with sympathetic low-level planting and interpretation boards the visitor experience will be enhanced. However, much still remains to be done. The specialist stabilisation work on the walls is not yet complete (or even started) and the walls remain in a precarious state (Photo 3).

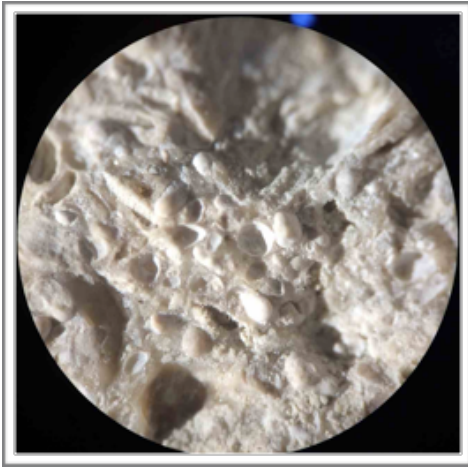
In the second instance, when the freshly spalled areas of the L-shaped stone were examined with the USB microscope, I saw evidence of the *Neomiodon* fossil shells consistent with Downs Vein as described above (Photo 3). There was no evidence of the *ooliths* that make up Portland Stone present anywhere in the L-shaped stone. Further, the flaked-off areas of the L-shaped feature are consistent with the way Downs Vein tends to flake off,

**Photo 3:** Fossil *Neomiodon* shells in Downs Vein Stone

confirming that this feature is definitely Downs Vein and not Portland Stone.

According to Mr Webster, Downs Vein was used primarily as paving for floors and certainly would not have been suitable for a wall, much less a window casement. The L-shaped of the stone is consistent with it being originally cut to fit on the floor around the projections formed by a fireplace or staircase. So what is it doing in the Keep's wall? The stone was more likely taken from another building elsewhere and used to repair the walls of the Keep much later in its

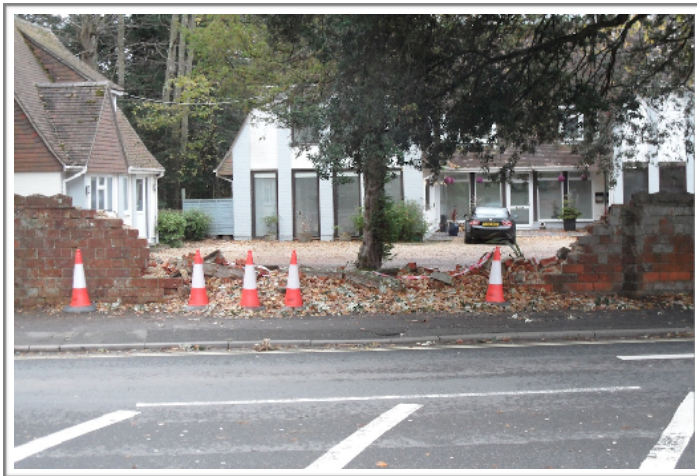
**Photo 1:** *The demolished section of wall*

Sadly the wall has recently suffered quite extensive damage due to a traffic collision resulting in the demolition of several metres of the wall (Photo 1). Just how it will be restored is a mystery, since the original bricks are no longer produced commercially. Possibly some bricks may be salvaged and reused although the interlocking nature of these patent bricks seems to have resulted in the majority of them being fractured in the collision (Photo 2, left) and not breaking along the lines of mortar as would have happened with the usual rectangular bricks. Unfortunately, the wall is adjacent to a busy main road and already bears the scars of many lesser traffic incidents and is subject to other examples of wear and tear, such as damage by tree roots (Photo 2, right), and incongruous repair with inappropriate materials. Unfortunately our built heritage is continually at risk, whether by accident or neglect, and this sad spectacle is just another reminder.

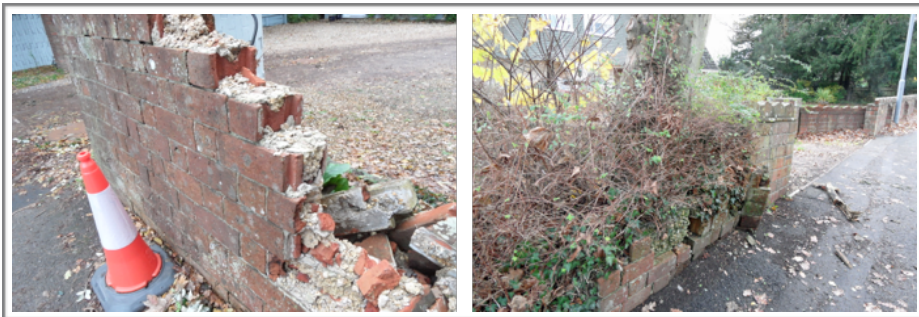
*Photo 2: Left - Section showing the interlocking style of the bricks; Right - The damaged caused by tree roots in another section of the wall*

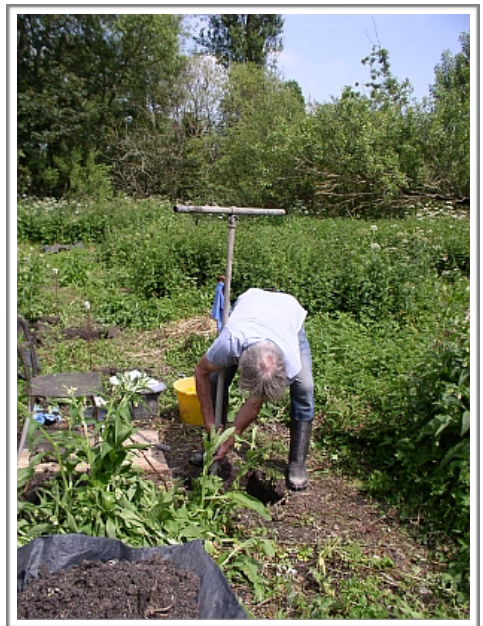
With some bits and pieces from my garage I constructed an auger approximately 2.2 metres long from an aluminium tube and a short length of angle iron. This one was called “Big T” by one of our members (Photo 1).

**Photo 1:** Mike and “Big T”

The sampling section of the new auger was only about 0.3 metres long, so we had to take a number of samples and measure the depth as we went down until we hit hard gravel (in most cases). The gravel turned out to be grey river gravel, indicating that at least the northern

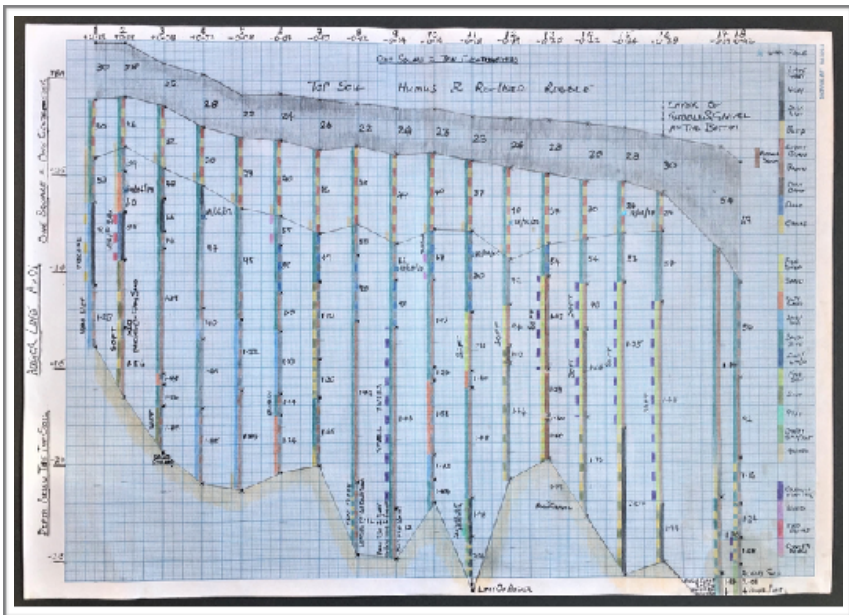
Reflecting our previous pit digging, it would appear that a good part of the northern end of the garden was low lying and had flowing water running over it at some time, although to get a more accurate picture of what was going on there, we will need to extend augering to that area (Photo 2).

**Photo 2:** Graph plotting the layers and depth of Auger Line 1 (vertical scale exaggerated) - compiled by Steve Fox.

Lines 3 and 4, moving south towards the donkey shed, also reflect our previous findings that the ground below is generally rising in height, with a brief dip where the possible channel is running. Here it appears that the natural subsoil is no longer the grey river gravel of the northern area, or the

natural orange gravel we have seen elsewhere, but a fine pale orange silt with thin layers of sand (some of which has a blue/green hue due to a small iron content). Just above the subsoil is a thick layer of dark brown to dark grey silt which may be the original medieval occupation layer because it contains deposits of medieval pottery. The dark colour of this layer is probably due to organic matter and is between 1 and 1.5 metres below the present ground.
